LOWER CONNECTICUT RIVER BASIN  
ESSEX , CONNECTICUT

MILL POND DAM  
CT 00423

PHASE I INSPECTION REPORT  
NATIONAL DAM INSPECTION PROGRAM

APRIL 1980

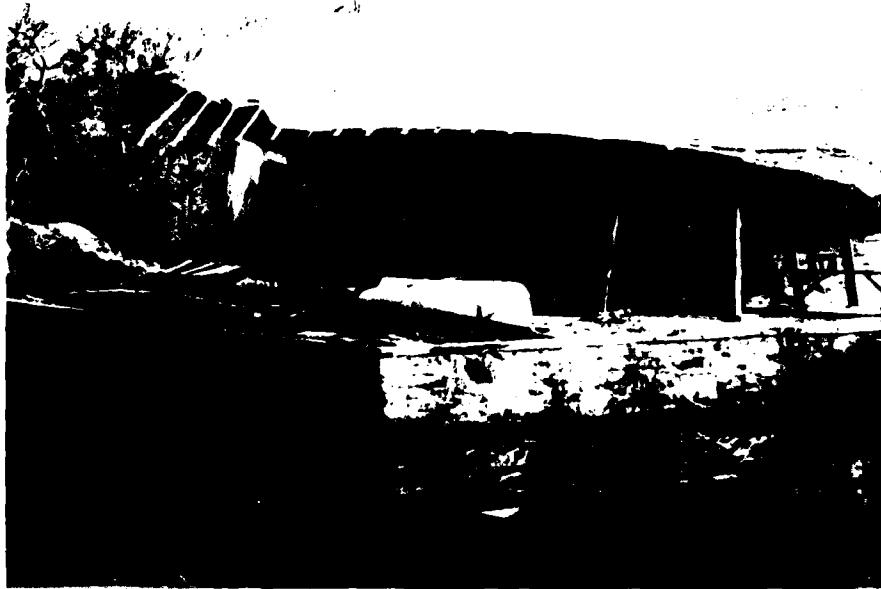
1) Upstream Face - The upstream face of the dam is comprised of mortared stone masonry (see Photo No. 13). The stone pointing is in fair condition. Several voids in the upstream face indicate that material has been lost by erosion.

PHOTO #13: Upstream face and crest of dam, from left side.
